CONCRETE SOLUTIONS

Vapor Trails

Battling Water Vapor in Concrete

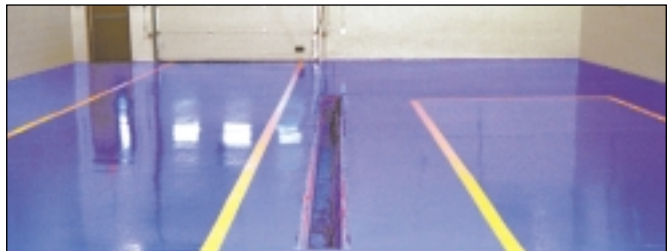
With vapor barrier laid, aggregate is broadcast, followed by an intermediate pigmented polyurea coating and clear skid-resistant topcoat. Concrete substrate, vapor barrier, and wear surface now combine to create a protective floor system.

Epoxy formulas used as vapor barriers are near the consistency of water when applied. They are applied directly onto the cleaned concrete surface with squeegee and rollers. The modified epoxy penetrates into the cement and fills voids and micro cracks in the area of treatment. Typically, a single application is sufficient to stop vapor transmission with rates up to 14 lbs. / 1,000 ft². A second application of product has been shown to stop vapor transmission at rates up to 19 lbs. / 1,000 ft². The drawback is that these vapor-stopping systems cannot be used as wear surfaces and require the appropriate overlayment to protect them.
